Oakbank Accessibility Action Plan April 2023

4.1 - ACTION TABLE

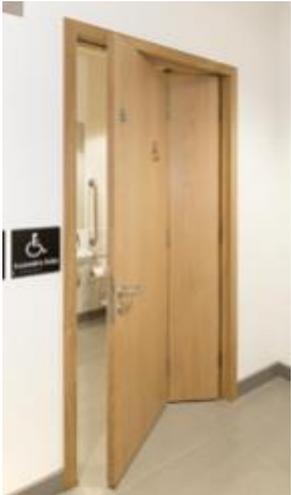
<p>13.3</p>	<p>Most facilities featured doors that suitably opened outwards.</p> <p>The first-floor facility, 637, opened into the doorway of F33, which could be a collision hazard.</p> <p>Facility 638 partially opens into the doorway of F5, which could be a collision hazard.</p> <p>208 partially opens into G16, which could be a collision hazard.</p>	<p>It is recommended to provide bi-folding, or sliding doors for these facilities to reduce the risk of a collision.</p>

<p>M</p>	<p>All toilets are designed and are in specification with accessibility regulations. The doors can only open outwards as the door would not close if opened inwards if a wheelchair was used.</p>
<p>13.10</p>	<p>Items were identified in each of the facilities transfer areas.</p> <p>Items within these areas can prevent a wheelchair user from adopting the appropriate techniques in order to access the facility.</p>	<p>It is vitally important and is strongly recommended that a management procedure be implemented to ensure that accessible WC facilities are always kept clear.</p> <p>☒ This will enable wheelchair users to adopt the many transfer techniques available to them in which an accessible WC is designed to provide. Without a free transfer area, a wheelchair user is highly unlikely to be able to use a facility.</p>	<p>N</p>	<p>These items were medical bins and are needed. The Bins do not obstruct access.</p>

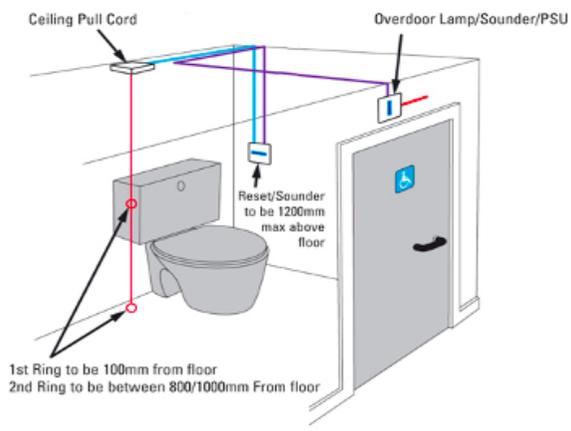
13.11

Many of the facilities featured suitably positioned cord alarms.

Tied cord alarms were identified by S44, 830 and 638.

The cord alarm in the sports building facility was positioned on the shelf.

The cord alarm in the CTMC building was high from ground floor level and a reset button was not identified.

☒
According to BS8300 - An emergency assistance pull cord should be sited so that it can be operated from the WC and from an adjacent floor area. The emergency assistance pull cord, coloured red, should be provided with two red bangles of 50 mm diameter, one set at a height between 800 mm and 1000 mm and the other set at 100 mm above floor level.

Implement a management procedure to ensure that cord alarms are always kept loose and not tied up.

Pull cords will be checked and repairs/adjustments carried out.

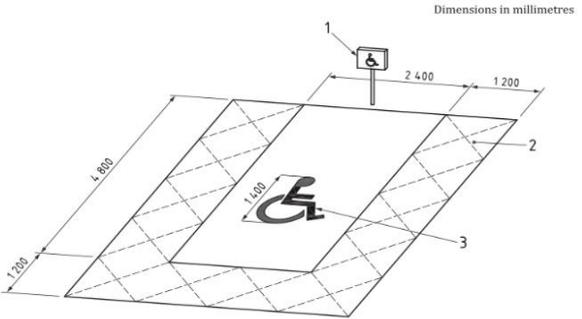
<p>2.2</p>	<p>Posts were identified to the front of the bays; however, these did not feature appropriate accessible bay signage. The signage provided at the entrance to the car park could be improved.</p>

<p>Key</p> <p>1 Sign, with its lower edge 1 000 mm above the ground, to identify parking space when road markings are obscured, e.g. by snow or fallen leaves, with the words "Blue Badge holders only"</p> <p>2 1 200 mm wide access zone between designated accessible parking spaces</p> <p>3 International Symbol for Access (see BS 8300-2:2018, Figure 9)</p>	<p>Install a sign to the front of any accessible parking space. According to BS8300 - Sign should be present with its lower edge 1000 mm above the ground, to identify parking space when road markings are obscured, e.g. by snow or fallen leaves, with the words "Blue Badge holders only".</p> <p>Refer to BS8300, A sign or, if appropriate, signs should be provided at the entrance to each car park and at each change in direction to direct disabled motorists to designated parking spaces.</p> <p>As the signage provided is updated, consideration should be taken to removing the word "disabled" and replacing it with "accessible" or "Blue Badge Holders".</p>	<p>M</p>	<p>Signs to be ordered</p>

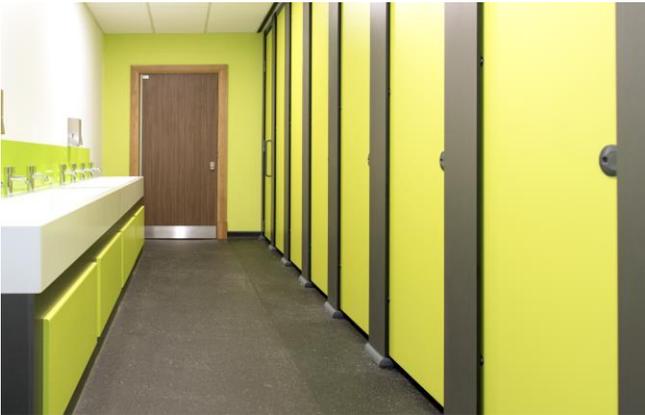
<p>12.4</p>	<p>The lock was slightly broken on the female, staff facility on the second floor.</p> <p>Student WC facilities did not have contrasting cubicle doors as they were the same colour as the frames. This could be confusing for people who are partially sighted.</p>	<p>Site management to schedule maintenance and repair of the lock for the staff, female facility on the first floor.</p> <p>Cubicle doors throughout should appropriately colour contrasted to identify doors within frames to aid people with impaired vision. A difference of 30 points LRV (Light Reflectance Value) is recommended as appropriate contrast.</p>

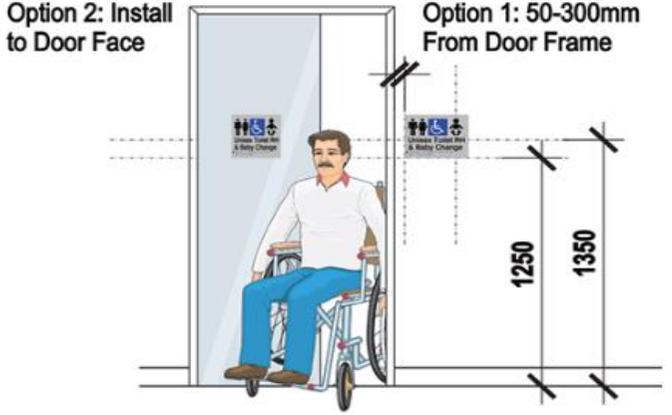
15.3	<p>Most facilities featured suitable signage across the school.</p> <p>The shower room for staff, in the sports centre, was not suitably sign posted to assist with identifying its location.</p> <p>There is accessible WC signage positioned marginally high from ground floor level, at approximately 1470mm, which may not be a suitable height for all eye levels.</p>

<p>The appropriate signage should be provided for the staff facilities in the sports centre. As well as signage on the doors, there should also be signs indicating where the facilities are located.</p> <p>BS8300 states - Information and direction signs should be provided at each point where they are required, e.g. at junctions of circulation routes, at key locations such as doorways and reception points, at facilities such as telephones and toilets, and in rooms, spaces and counters. The colour, design and typeface of signs should be consistent throughout a building.</p> <p>All accessible WC door signage should ideally be accessible to all disabled people with Braille and embossed lettering preferred. This should be suitable positioned for all eye levels.</p>	M

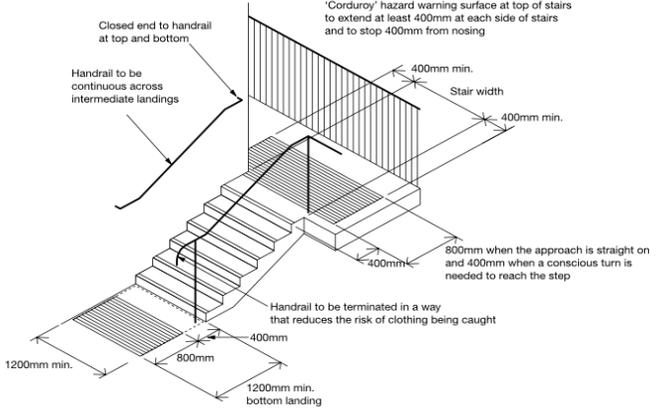
<p>4.1</p>	<p>Tactile warnings were provided to the steps that lead from the car park, towards the main entrance.</p> <p>The remaining external steps identified did not feature tactile paving to the top or bottom, which could assist people who are blind or partially sighted, by providing prior warning of the steps.</p>

<p>Implement a rolling programme to install tactile paving to the top of the external steps throughout the site.</p> <p>BS8300 - To give advance warning of a step, tactile paving with a corduroy hazard warning surface should be provided at the top and bottom of each flight, excluding intermediate landings with continuous handrails. Where the approach to the stair is wider than the flight, the tactile surface should extend beyond the line of each edge of the flight.</p>	<p>M</p>	
<p>4.3</p>	<p>Are all external steps adequately lit during darker hours?</p>	<p>Site management should undertake a review of the step lighting levels during darker hours to ensure that the step treads are evenly lit.</p> <p>Lighting on external steps and ramps should achieve a minimum level of 100 lux where they are external and adjacent to entrances/exits of buildings.</p>	<p>N</p>

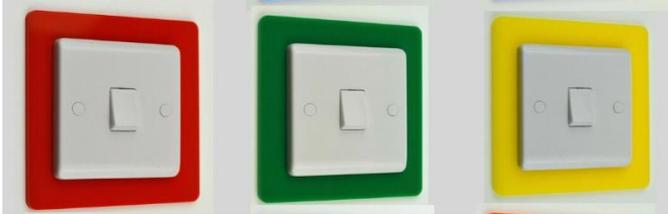
<p>16.2</p>	<p>Many of the light switches were well contrasted against their surroundings.</p> <p>The light white switch plates against light surroundings may not provide sufficient contrast to assist people who are partially sighted.</p>

<p>At the next refurbishment for the sites, it would be beneficial to change the existing light switch plates with alternatives that have a grey/silver plate. Alternatively, a contrasted border could be provided. This will ensure that they are easily located by people with impaired vision.</p> <p>All switches that require precise hand movement, such as light switches, thermostats etc, should be located between 750mm – 1200mm from floor level.</p>	<p>M</p>
