# Beckfoot Oakbank School - Accessibility Action Plan.

Updated: 15/09/2025

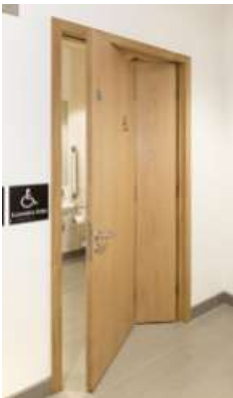
13.3	Most facilities featured doors that suitably opened outwards.  The first-floor facility, 637, opened into the doorway of F33, which could be a collision hazard.  Facility 638 partially opens into the doorway of F5, which could be a collision hazard.  208 partially opens into G16, which could be a collision hazard.	It is recommended to provide bi-folding, or sliding doors for these facilities to reduce the risk of a collision.

M	All toilets are designed and are in specification with accessibility regulations. The doors can only open outwards as the door would not close if opened inwards if a wheelchair was used.

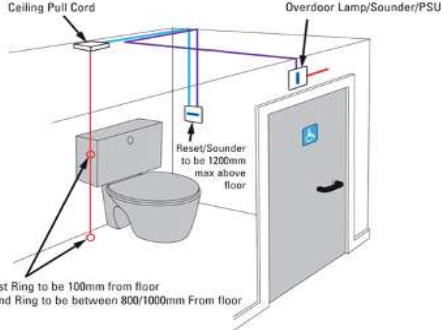
13.11	<p>Many of the facilities featured suitably positioned cord alarms.</p> <p>Tied cord alarms were identified by S44, 830 and 638.</p> <p>The cord alarm in the sports building facility was positioned on the shelf.</p> <p>The cord alarm in the CTMC building was high from ground floor level and a reset button was not identified.</p>	<p>Implement a management procedure to ensure that cord alarms are always kept loose and not tied up.</p> <p>According to BS8300 - An emergency assistance pull cord should be sited so that it can be operated from the WC and from an adjacent floor area. The emergency assistance pull cord, coloured red, should be provided with two red bangles of 50 mm diameter, one set at a height between 800 mm and 1000 mm and the other set at 100 mm above floor level.</p>

N	<p>Pull cords will be checked and repairs/adjustments carried out.</p>

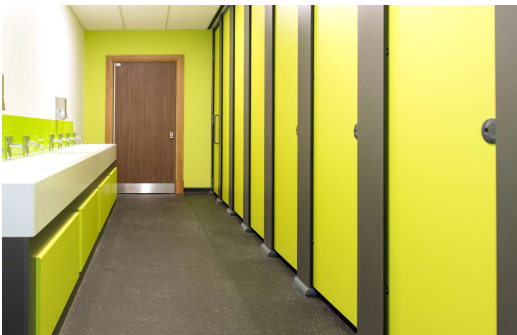
12.4	<p>The lock was slightly broken on the female, staff facility on the second floor.</p> <p>Student WC facilities did not have contrasting cubicle doors as they were the same colour as the frames. This could be confusing for people who are partially sighted.</p>	<p>Site management to schedule maintenance and repair of the lock for the staff, female facility on the first floor.</p> <p>Cubicle doors throughout should appropriately colour contrasted to identify doors within frames to aid people with impaired vision. A difference of 30 points LRV (Light Reflectance Value) is recommended as appropriate contrast.</p>

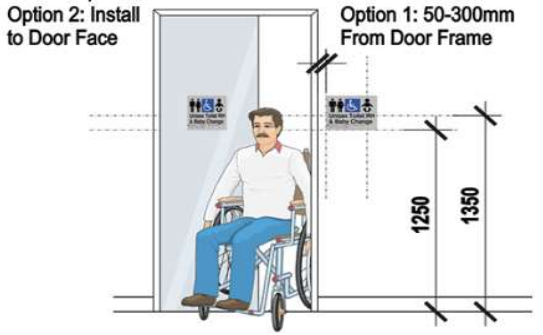
15.3	<p>Most facilities featured suitable signage across the school.</p> <p>The shower room for staff, in the sports centre, was not suitably sign posted to assist with identifying its location.</p> <p>There is accessible WC signage positioned marginally high from ground floor level, at approximately 1470mm, which may not be a suitable height for all eye levels.</p>

<p>The appropriate signage should be provided for the staff facilities in the sports centre. As well as signage on the doors, there should also be signs indicating where the facilities are located.</p> <p>BS8300 states - Information and direction signs should be provided at each point where they are required, e.g. at junctions of circulation routes, at key locations such as doorways and reception points, at facilities such as telephones and toilets, and in rooms, spaces and counters. The colour, design and typeface of signs should be consistent throughout a building.</p> <p>All accessible WC door signage should ideally be accessible to all disabled people with Braille and embossed lettering preferred. This should be suitable positioned for all eye levels.</p>	M

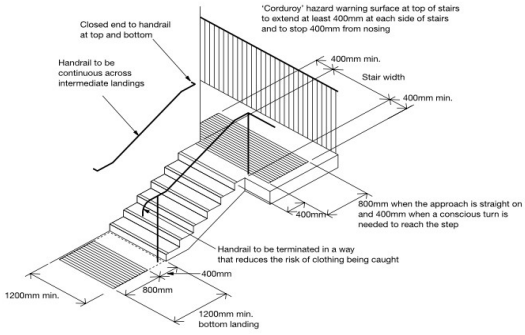
4.1	<p>Tactile warnings were provided to the steps that lead from the car park, towards the main entrance.</p> <p>The remaining external steps identified did not feature tactile paving to the top or bottom, which could assist people who are blind or partially sighted, by providing prior warning of the steps.</p>

<p>Implement a rolling programme to install tactile paving to the top of the external steps throughout the site.</p> <p>BS8300 - To give advance warning of a step, tactile paving with a corduroy hazard warning surface should be provided at the top and bottom of each flight, excluding intermediate landings with continuous handrails. Where the approach to the stair is wider than the flight, the tactile surface should extend beyond the line of each edge of the flight.</p>	M
